# Manhole Inspection Summary

Manhole # S07YY1004MH

Insp Date: **9/21/06 7:57 AM**

**Location** Address: **2912 GLEN AVE**

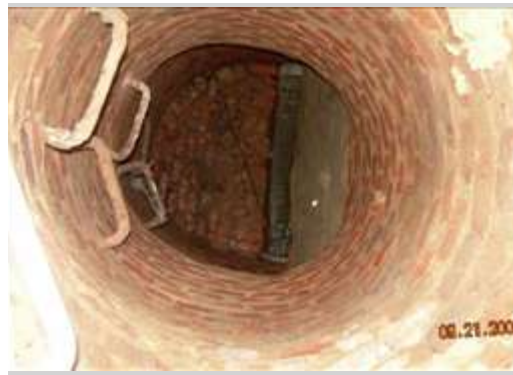
Top View

Comments **Cannot take measurements.....manhole offset to the right.**

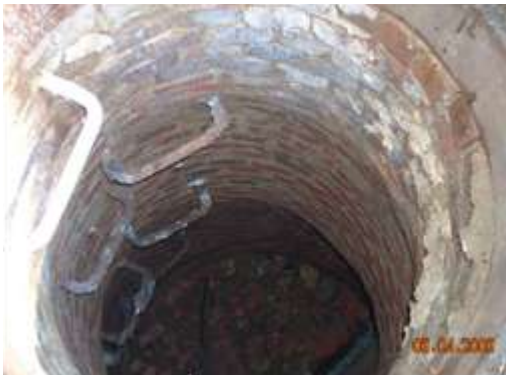
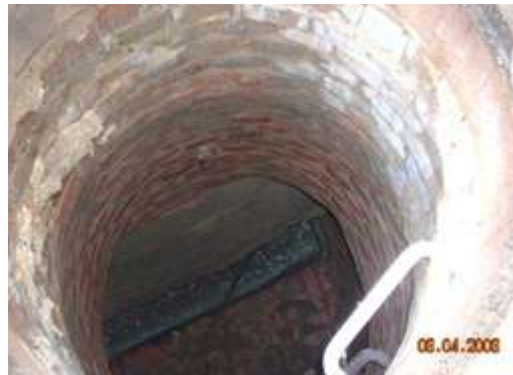
Defect

☐ Parged ☒ Debris (not Condition related)

Count: **5** Missing: **0** ☒ Corroded

Corroded steps. Evidence of surcharge - Bench debris.

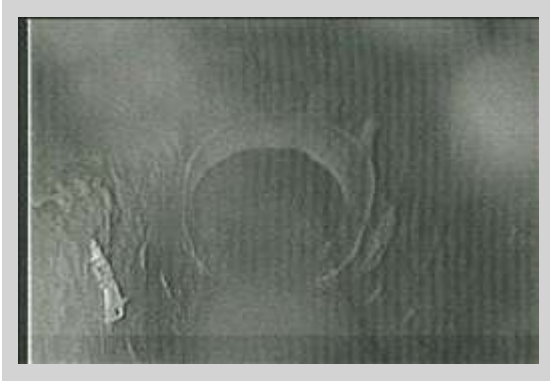
### 12 in. Circular Gravity Sewer Pipe Out @ 12 O'Clock

Direct (Angled)

Invert Depth: **12.10** (ft.) Flow Characteristics: **Fast**

Infiltration: **None**
